Utilization of Unmanned Aerial Vehicle (UAV) for Shoreline Changes Mapping

Abstract

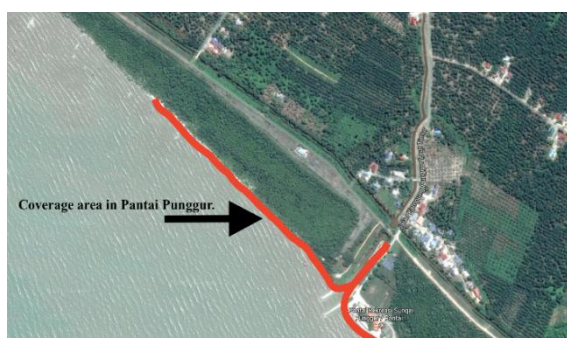
Figure 1: Aerial view of PantaiPunggur (The 1000m study area is marked with red line)

The place of the study was section of the coastal area at Pantai Punggur, Senggarang, Batu Pahat, Johor as illustrated in Figure 1. The total shoreline of Batu Pahat is placed at latitude 1.62° to 1.87° N, longitude 102.78° to 103.19° E [17]. Batu Pahat are the more vulnerable area to coastal erosion danger which happens on a continuous basis beginning in 2007[18]. Earlier study concluded that in this 40-year period, the shoreline shifted to the land up to 300 m away or ranged around 5 m to 7.5 m a year[19]. In another analysis, the shoreline changes ranged from 50 m to 200 m through an maximum annual shift of 1.5 m to 7 m, since 1984 to 2013[20]. This has been related to the element of erosion and sedimentation generated by waves, currents and winds of these natural factors.

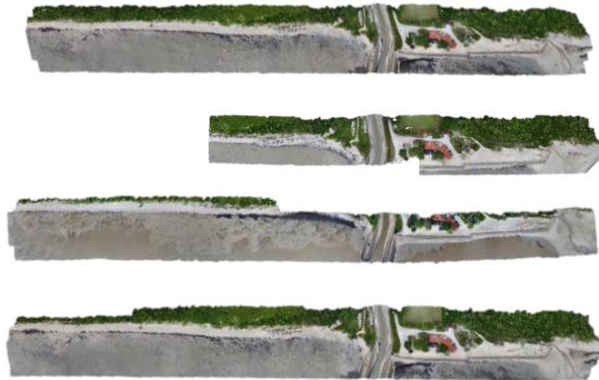
Figure 8: Aerial Images of study area from August, September, October and November 2017 (top to bottom), respectively

Figure 8 shows the aerial images which were obtained from August to November 2017. Figure 9 shows the lines representing changes in the shoreline over the consecutive four-month study duration. Although Figure 10 on the right hand side of PantaiPunggur shows the shoreline at high tide.

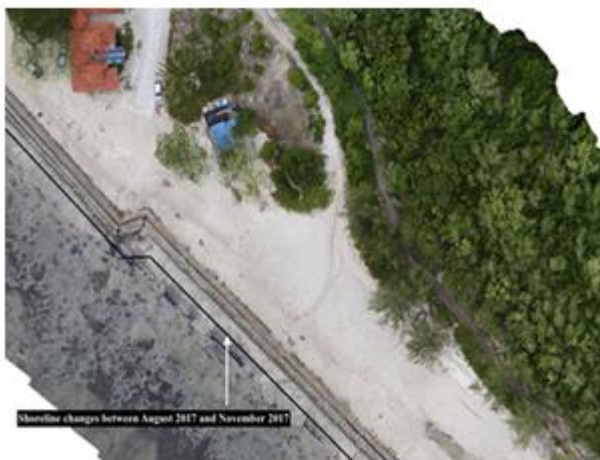
Figure 10: Shoreline during high tide on the right side of PantaiPunggur

During high tide certain shoreline changes became clearly visible as they eroded from August to November 2017. The shoreline changes are clearly noticeable in four months and may in the immediate future impact the coastal site. To assure the people's safety who live in PantaiPunggur, prevention must be undertaken. While no modifications were observed after the overlaying process based on visual inspection at the right side of PantaiPunggur. The first line describing the first shoreline

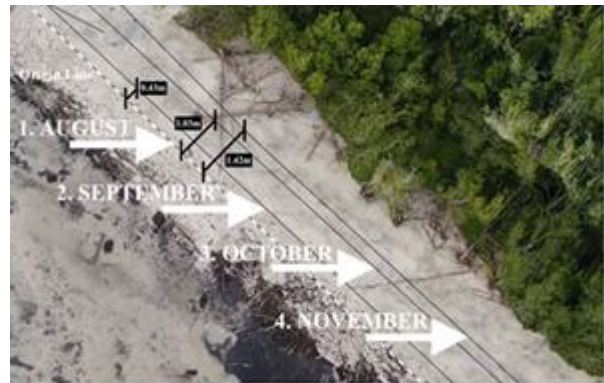
Figure 11: The shoreline during high tide represented by lines of the consecutive four months

in August began off the beach based on the study. When time went by, the line was moving inwards towards the ground. Figure 11 shows the lines that formed after being overlaid on that image.

Referring to Figure 11, the shoreline distance variation from August through November 2017 was about 1.42 m. According to the monsoon season between August and November, the major shoreline changes may have occurred. This can be concluded which shoreline changes are unavoidable during high tide in PantaiPunggur, unless adequate prevention has been put into action. It can cause short-term deficiencies or erosion due to its rapid day-to-day changes. Coastal erosion, including changes to shoreline, can harm people. In fact, without warning, those changes are coming up quickly.
