# Detection and Characterization of Defect in Carbon Fiber Reinforced Composite Laminate Using Passive Thermography

Real-time non-destructive assessment is important during load testing of composites. Overlay for rising use of Carbon Fiber Reinforced Polymer (CFRP), the fast, visible, and free of Interference technique for discovering mechanical influence deterioration is critical requirement. The main concept of the research experiment using passive thermography is to locate the damaged areas during polymer deformation using the energy release. The test specimens were established over the temporal and spatial temperature distribution. Based on that, the forms of CFRP impact damage are described. The purpose of this paper is to use thermography and Ultrasonic to classify the types of impact damages. The results obtained show that under the different impact energies various types of impact damage occur and can be defined in the thermographic picture. Based on the fiber composite material used CFRP, Material thickness and impact energy a measure of sensitivity of the detection of these methods for the different damages is performed in this paper. The methods of thermography analysis

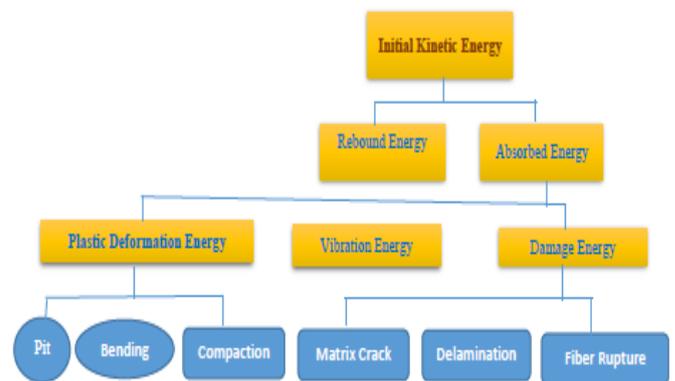
**Figure 1.** Energy conversion during impact experience on specimen

The example's energy transformation is set out in Figure 1 during the impact occasion. Suppose the head of the pendulum hits the example using a specific speed,  $C_1$  as an outcome, it is re-bounded by the sample with second specific speed  $C_2$ . As per the energy balance condition the misfortune active

energy,  $J_i$ , which is consumed by the example, can be gotten as appeared in condition (1),

$$J_i = J_p + J_v + J_d \quad (2)$$

Where  $J_p$  is the plastic deformation energy,  $J_v$  is sample vibrational energy,  $J_d$  is the damage energy

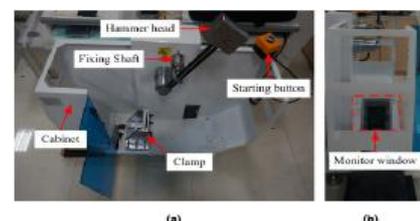
**Figure 2.** (i) Impact strategies. (ii) Observing window.

Illustration. 2 Standardized impact check gadget reveals itself. At Fig. 2(i) the pure pendulum head is used to reach the specimen where the heap sensor and the vibrating sensor are mounted to collect correlative information, such as contact strength, pace et al and some string gaps to include or decrease the tempered steel blockchanging the heaviness of the pendulum head to alter the vitality effect. The dynamic vitality of the pendulum head is determined by the impact vitality. The heavier pendulum head displays the higher impact vitality along these lines; the fixing shaft works in this with double power: Fixing of the pendulum head when measuring the impact and determining the underlying stature of the pendulum head; using the brace to speed up the example. In addition, the impact gadget and clip are placed in the desktop to forestall the impact instigated slag to sputter around.

As seen, this research focuses on the identification of impact defects and the representation of CFRP overlays using uninvolved thermography by estimating the surface temperature. We use the gadget for pendulum sway in Fig. 2 to re-enact the cause of the outside influence.The impact test is performed using 22.9°C room temperature and 29.99% humidity.The infrared camera is positioned at the screen window during the impact procedure, fig 2 (ii) the subtleties of the constant observation and of the related technique shall be reported as the accompanying five phases.

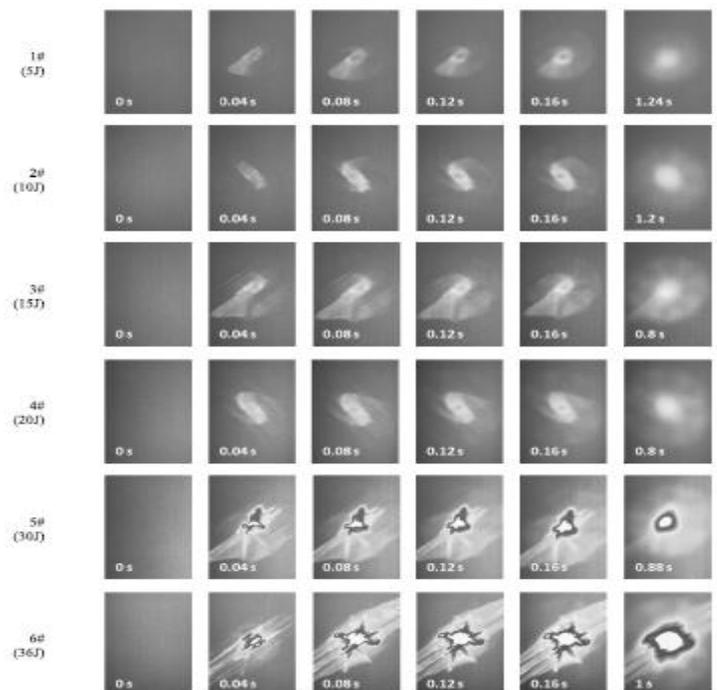
Figure 3. Series of thermal images captured by an infrared camera.

The accumulated picture outlines are set of eight hundred and the chronicle recurrence is set at twenty five hertz, i.e., each edge of thermography picture is assembled each 1/24 seconds and complete social occasion time is thirty two seconds in the detached thermography. The test subtleties are recorded in table I.

On sway occasion, the variable surface temperature using an infrared camera is measured and the comparative thermography image arrangement of examples with different energies appears in Fig. 3. At Fig. 3, Due to the effect caused by heat dispersion, the temperature of the problem area in the impact zone is higher than that of the sound region which can be used to detect the impact defect. There are also some significant wonders to be identified and investigated from the grouping of pictures, reported as follows:

- c) The problem area with higher effect vitality is more brilliant than that with lower sway vitality at a similar minute. Since the effect defect is increasingly genuine under the higher effect vitality, subsequently, the more warmth is dispersed and Prompts an example of a higher surface temperature.

- d) In the picture succession of examples #1 - #4, there is the nearness of a relative dim point in the focal point of problem area and the reasons are fundamentally gotten from that effect actuated pit prompts the decrease of thickness and the expansion of the nearby thickness, as per the condition,  $\alpha = k/\rho c$ , the comparing warm dispersion proficiency,  $\alpha$ , diminishes with the expansion of thickness,  $\rho$ , therefore, the capacity to will in general warmth balance decays. While in the picture arrangement of examples #5 - #6, no dull point yet more brilliant problem area (for example white spot) shows up, which demonstrates that the dispersed warmth increments pointedly under effect vitality from twenty Joule to thirty Joule. The explanation prompting this wonder is connected with the event of fiber crack that discharges copious warmth under bigger effect vitality.

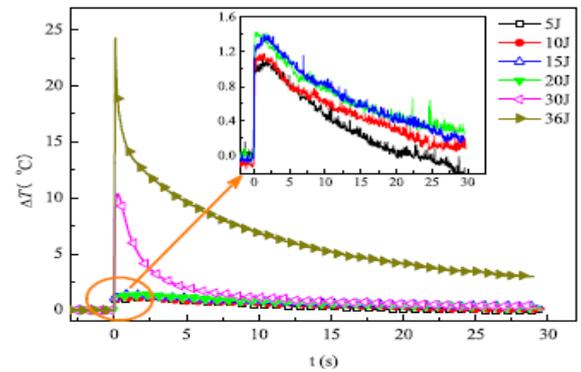
Figure 4. Example curves of surface temperature evolution.

Two zones called P1 and P2 are identified individually in the defect territory and sound zone and  $\Delta\tau$  subtracts the mean temperature between area P1 and zone P2. The bends of  $\Delta\tau$  versus  $\tau$  of examples with various effect energies is acquired utilizing Eq. (3), as appeared in Fig. 4. The  $\Delta\tau$  stays unaltered with the estimation of 0 °C at  $\tau < 0$  s, when the pendulum head doesn't hit the example. While, the  $\Delta\tau$  out of nowhere increments at  $\tau > 0$  s when the pendulum head hits the example to discharge warmth and afterward the  $\Delta\tau$  bit by bit diminishes because of the warmth trade with encompassing condition. The vaporous  $\Delta\tau$  decline marvel is available since the example surface responds to the effect in a versatile way (thermo-flexible impact) and the quick  $\Delta\tau$  increment wonder is because of the plastic response of example to affect occasion (thermo-plastic impact) in fig. 5.

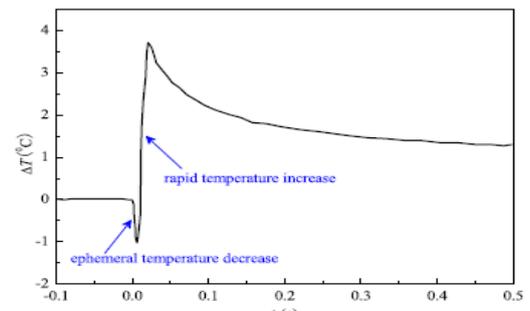
Figure 5. In the event of impact the ephemeral temperature decreases.

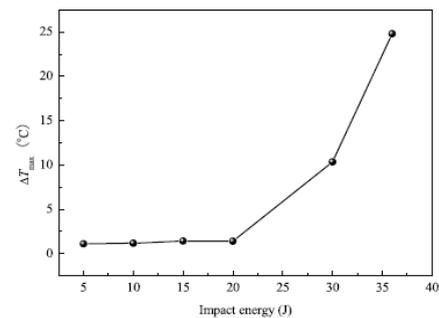
FIGURE 6.  $\Delta\tau_{max}$  for the species under different energy impacts.

The greatest extraordinary surface temperature  $\Delta\tau_{max}$  between P1 region and P2 region is plotted against sway vitality to examine the temperature changes under various impact energies in Fig. 6.

From Fig. 6, we can find that when the effect vitality is under twenty Joule, the  $\Delta\tau_{max}$  builds relative easily however under one and half °C, while when the effect vitality ranges to thirty Joule and thirty six Joule, the  $\Delta\tau_{max}$  spans to ten °C and twenty four °C separately, which demonstrates the  $\Delta\tau_{max}$  shows a nonlinear relationship with sway vitality. In detail, there might be the nearness of solid increment of  $\Delta\tau_{max}$  under some effect vitality between twenty Joule and thirty Joule, which is steady with marvels 3) and 4) and the explanation might be relative with the difference in sway defect types, i.e., network squeaking and delamination are the main forms of swaying defects when the impact vitality is below 20 Joule while the fiber breakage happens and goes with plenteous warmth dissemination when the effect vitality ranges to thirty Joule and thirty six Joule.
